DEPARTMENT OF TRANSPORTATION**DIVISION OF ENGINEERING SERVICES**

Contract #: 04-0120F4Cty: SF/ALA Rte: 80 PM: 13.2/13.9File #: 1.28**WELDING INSPECTION REPORT****Resident Engineer:**Pursell, Gary**Address:** 333 Burma Road**City:** Oakland, CA 94607**Report No:** WIR-014515**Date Inspected:** 03-Jun-2010**Project Name:** SAS Superstructure**OSM Arrival Time:** 1100**Prime Contractor:** American Bridge/Fluor Enterprises, a JV**OSM Departure Time:** 1930**Contractor:** American Bridge/Fluor Enterprises, a JV**Location:** Job Site**CWI Name:** See Below**CWI Present:** Yes No**Inspected CWI report:** Yes No N/A**Rod Oven in Use:** Yes No N/A**Electrode to specification:** Yes No N/A**Weld Procedures Followed:** Yes No N/A**Qualified Welders:** Yes No N/A**Verified Joint Fit-up:** Yes No N/A**Approved Drawings:** Yes No N/A**Approved WPS:** Yes No N/A**Delayed / Cancelled:** Yes No N/A**Bridge No:** 34-0006**Component:** Orthotropic Box Girders**Summary of Items Observed:**

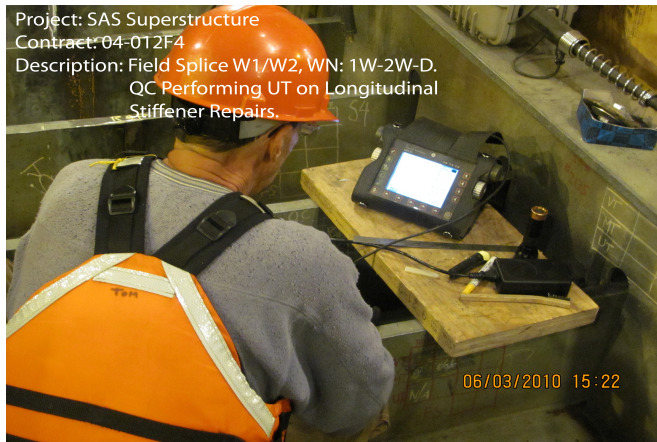
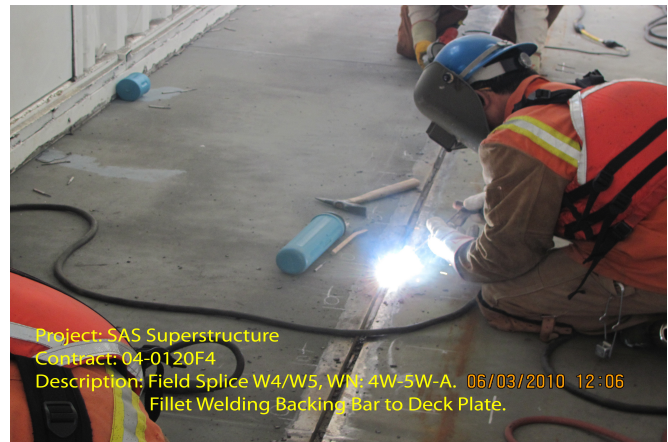
The digital photographs below illustrate the work observed during this scheduled shift.
